**HAZARD RANKING SYSTEM (HRS)
DOCUMENTATION RECORD - REVIEW COVER SHEET**

Name of Site: US Oil Recovery

HRS DOCUMENTATION RECORD

Date Prepared: September 2011

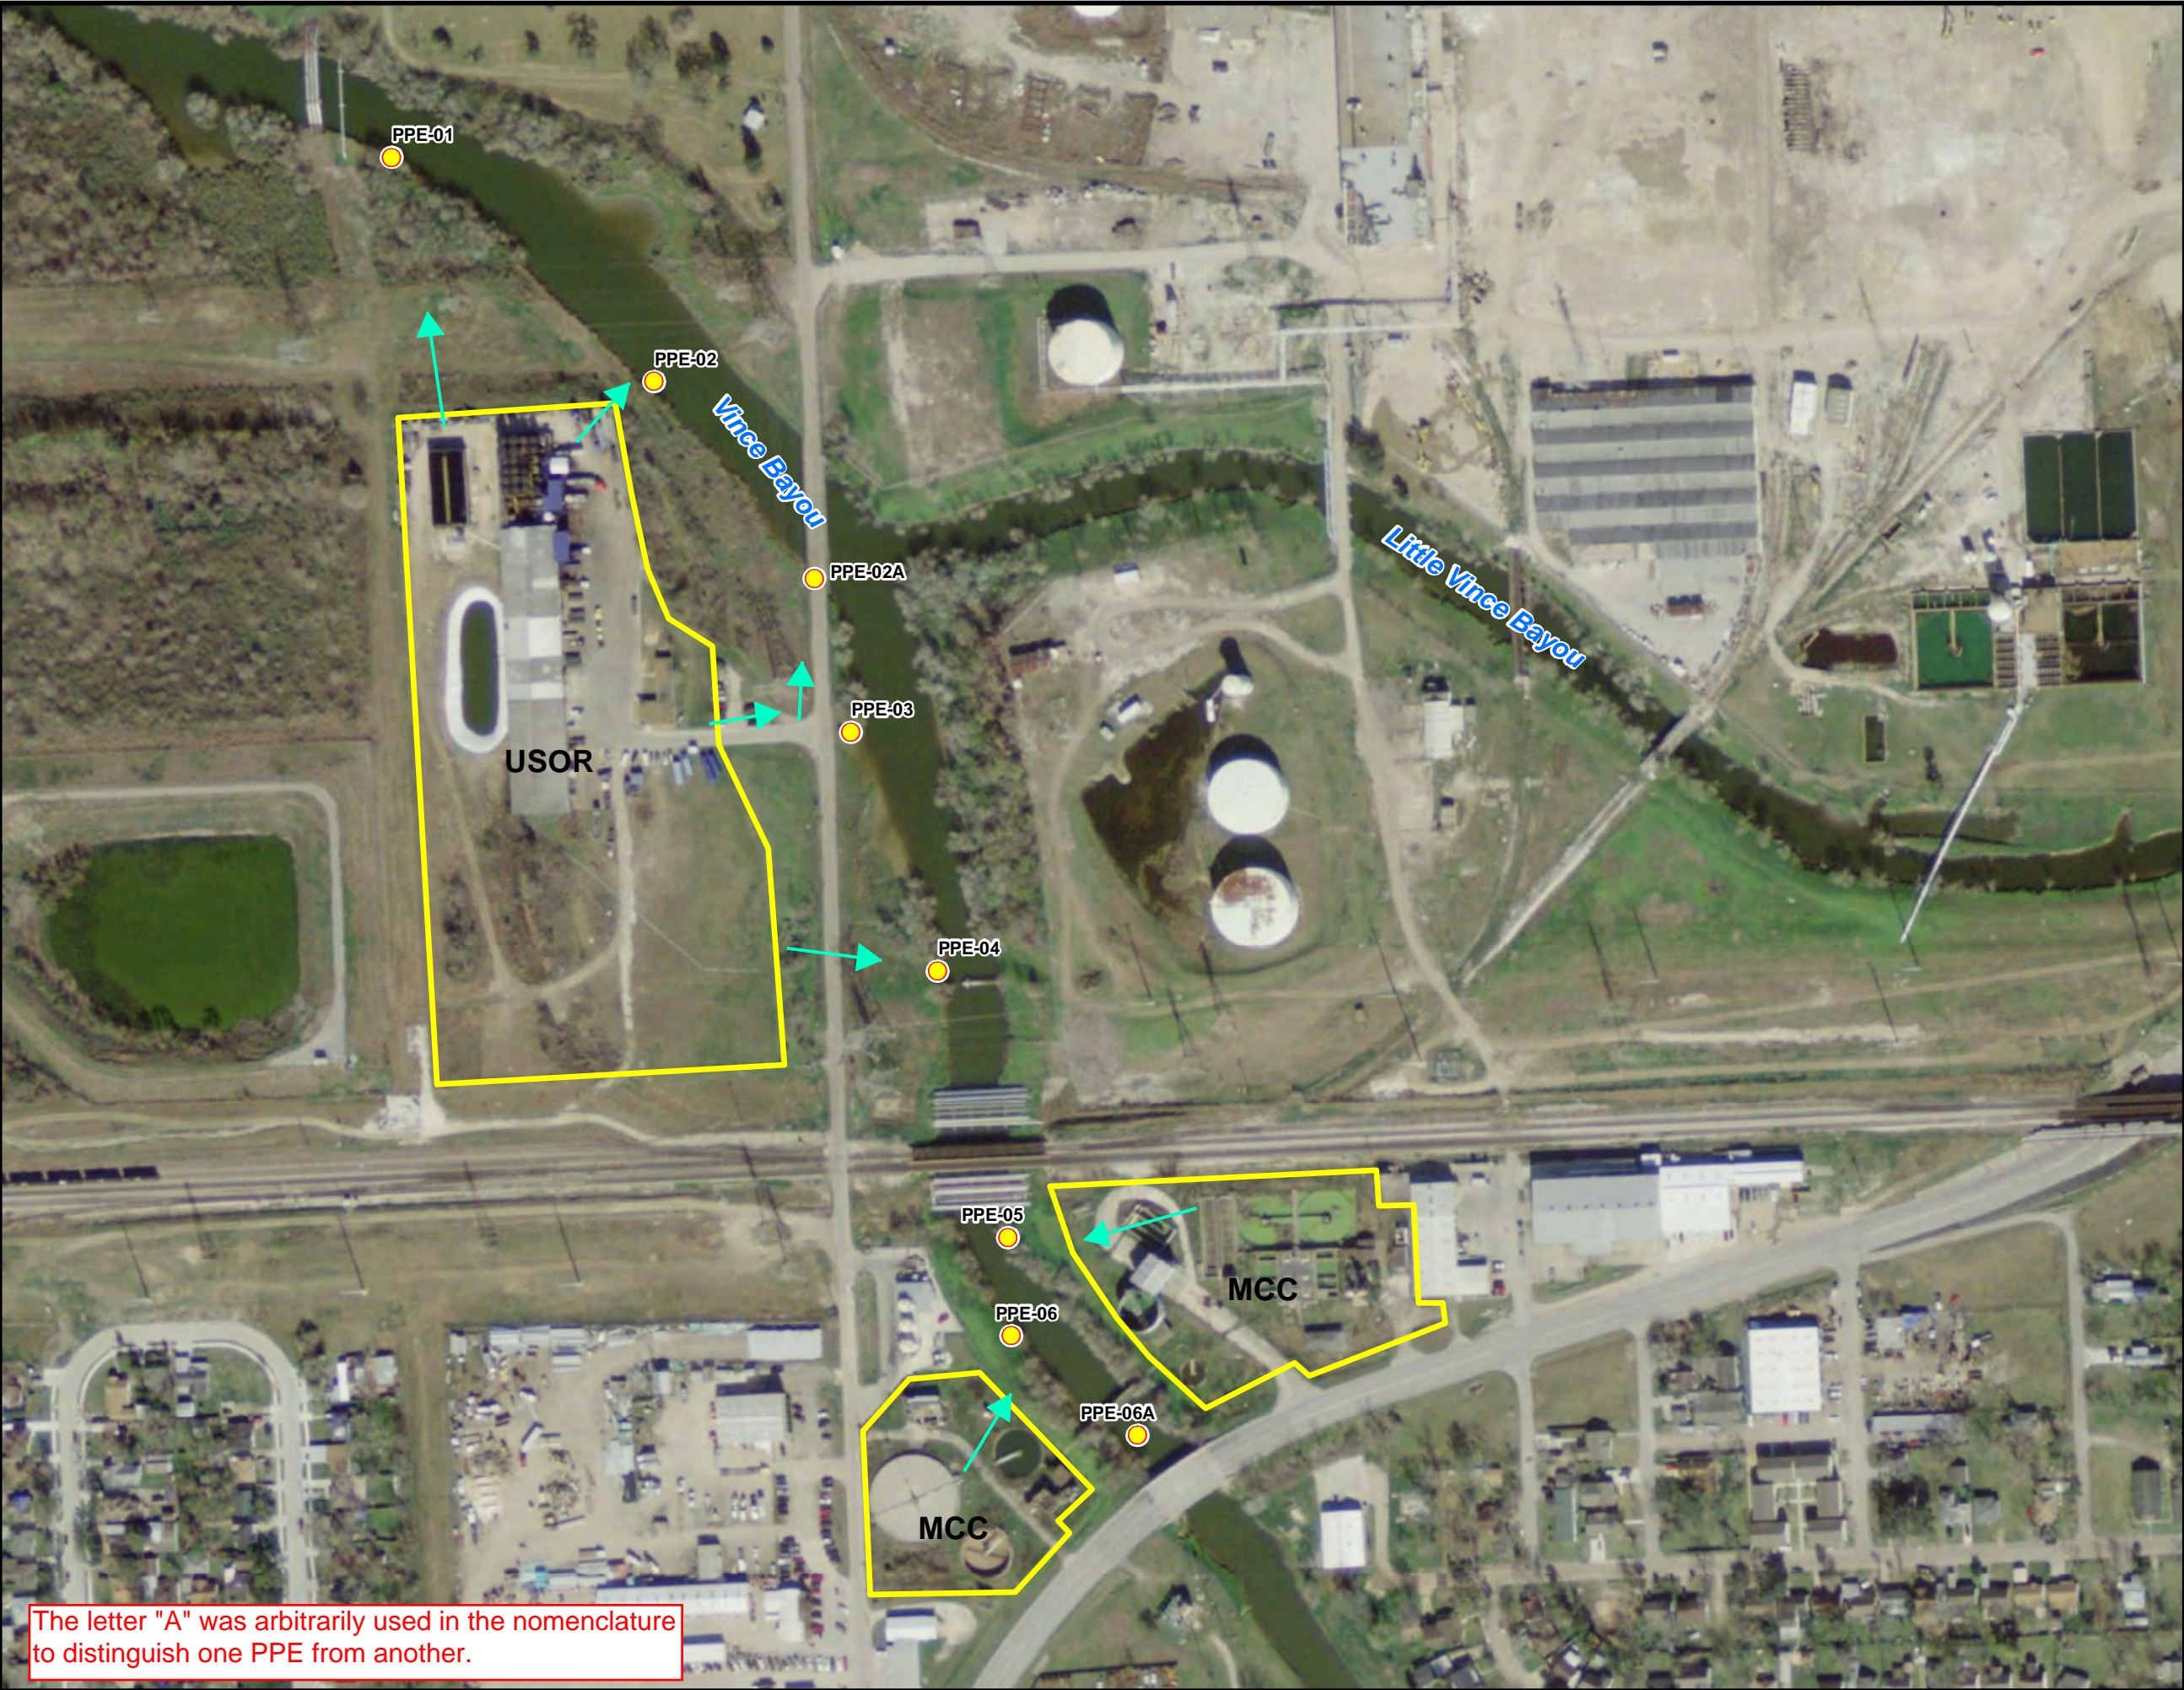
FIGURE A-3
SURFACE WATER PATHWAY MAP
US OIL RECOVERY
PASADENA, HARRIS COUNTY, TEXAS

- LEGEND
- PROBABLE POINT OF ENTRY
 - OVERLAND FLOW DIRECTION
 - SITE BOUNDARY
